BioMax Environmental

Post Mitigation Assessment Report
Department of General Services Board of Equalization Building
450 N. Street - 23rd Floor South and East Containment Areas
Sacramento, California

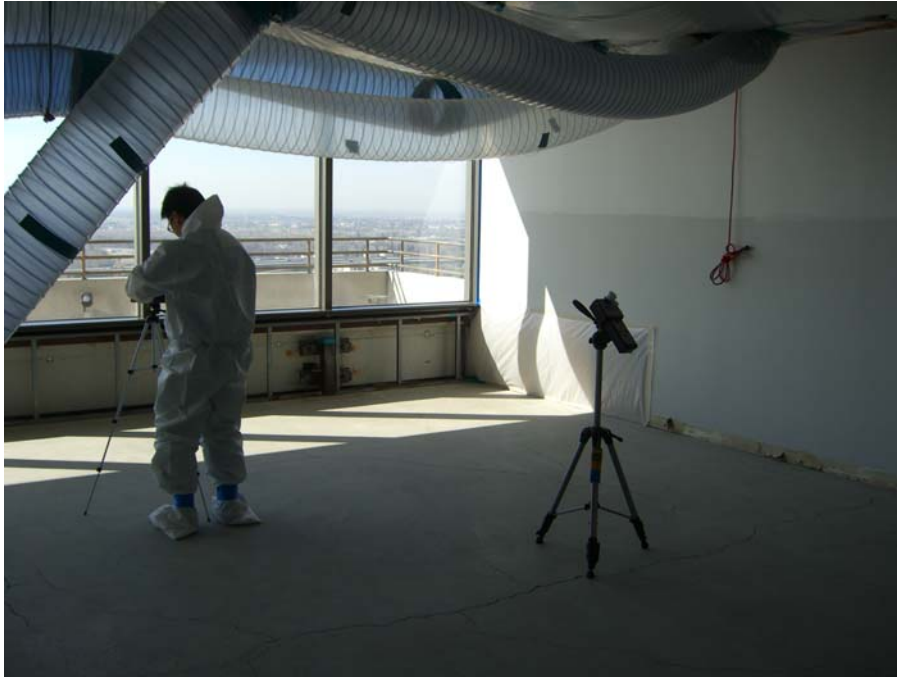
- 5) Image within 23rd Floor south containment area indicating location of air sampling equipment and “parallel” HTI technician activities.

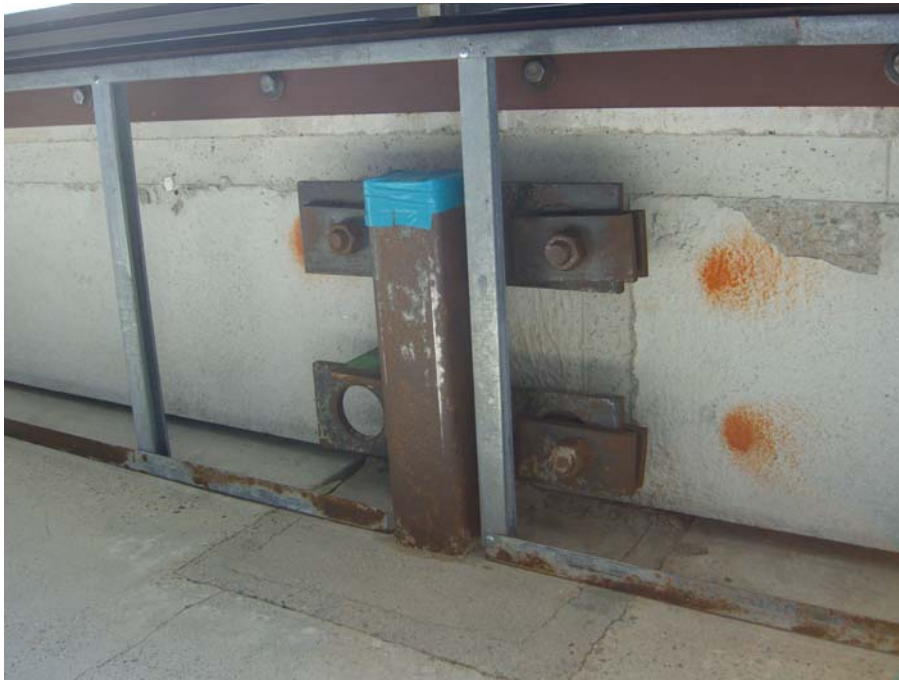
- 7) Close-up image of perimeter wall structures indicating evidence of prior water intrusion (corrosion on floor sill metal) following removal of damaged wallboard materials.

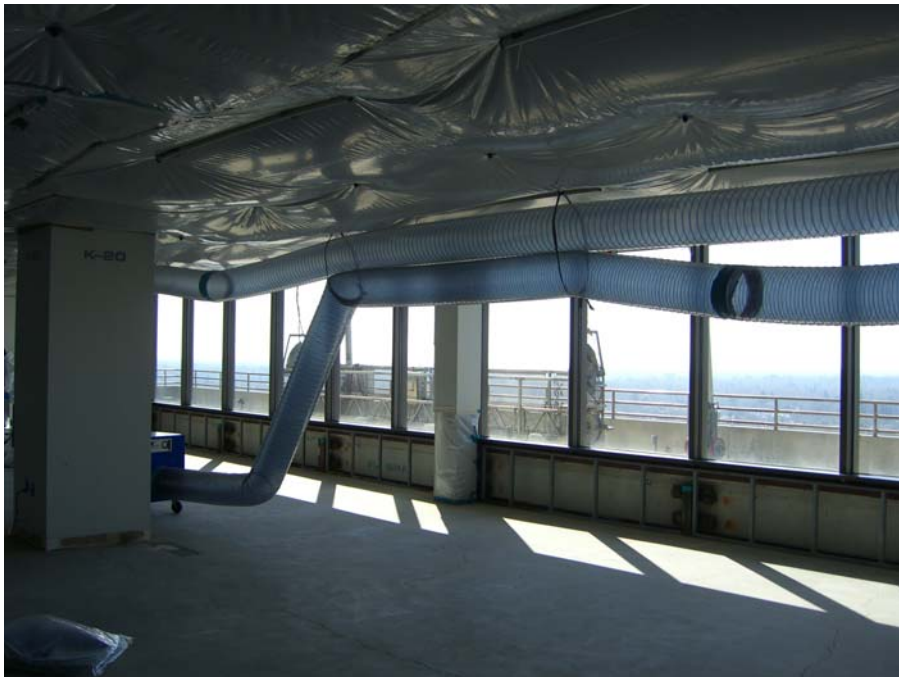
- 8) Wide angle image of 23South containment space indicating ventilation ducting and contained ceiling structures at time of assessment.

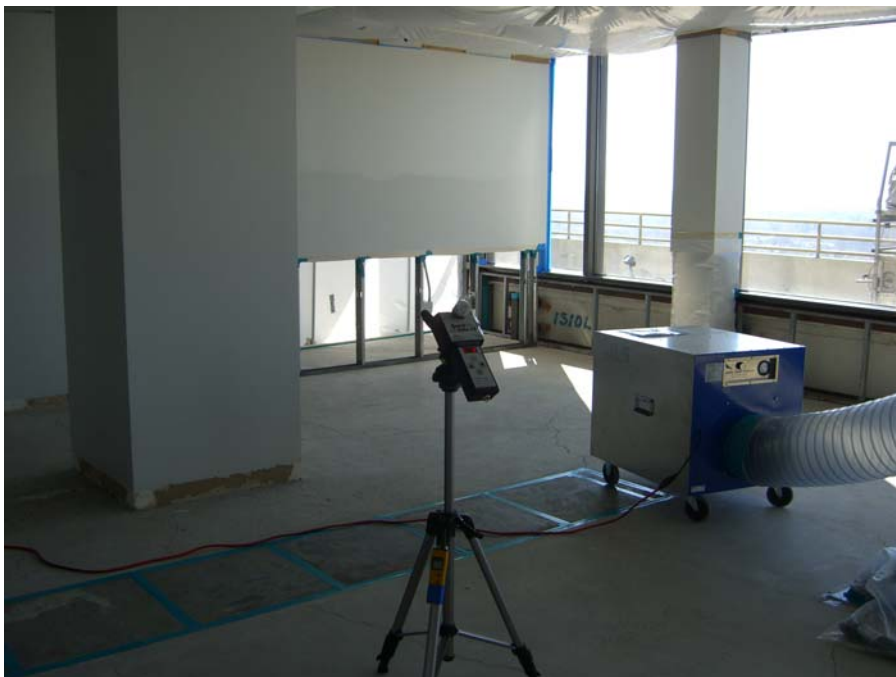
10) Image of air sampling equipment within eastern corner of 23 South containment area.

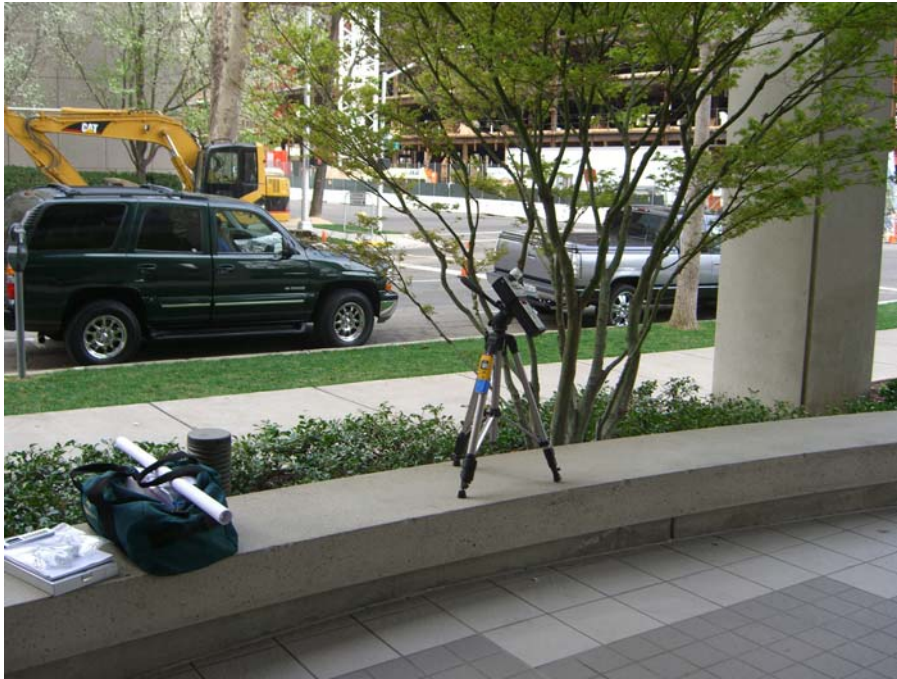
- 1) Image of ambient air sampling location at front entry of BOE Building (Subject Building) located at 450 N Street, Sacramento, California at time of assessment.

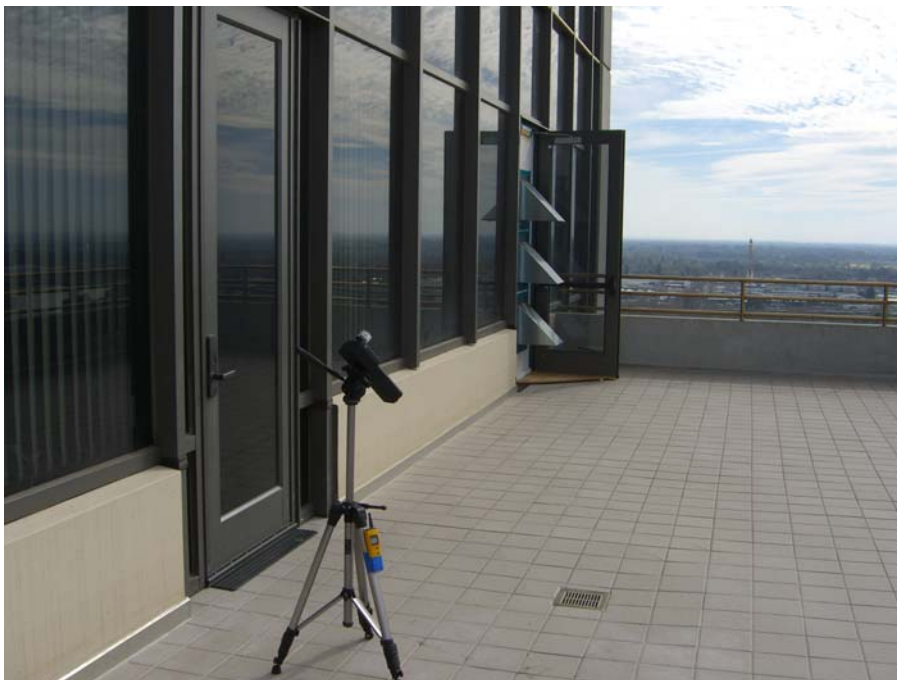
- 2) Image of Ambient air sampling location on balcony of 23 South at time of assessment.

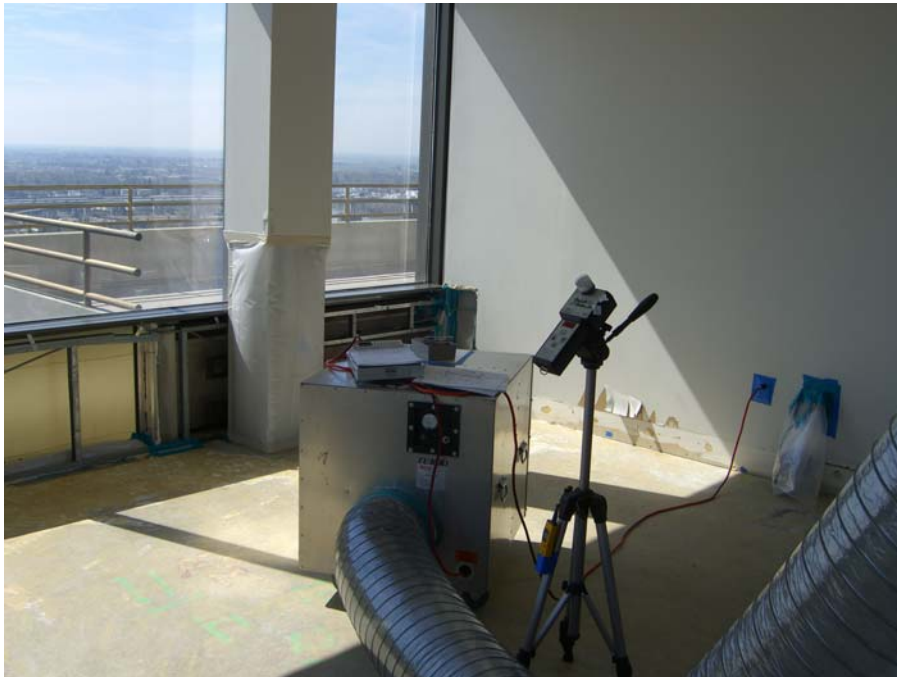
- 3) Image within 23 Eastern containment system indicating location of air sampling devices and air handling equipment at time of assessment.

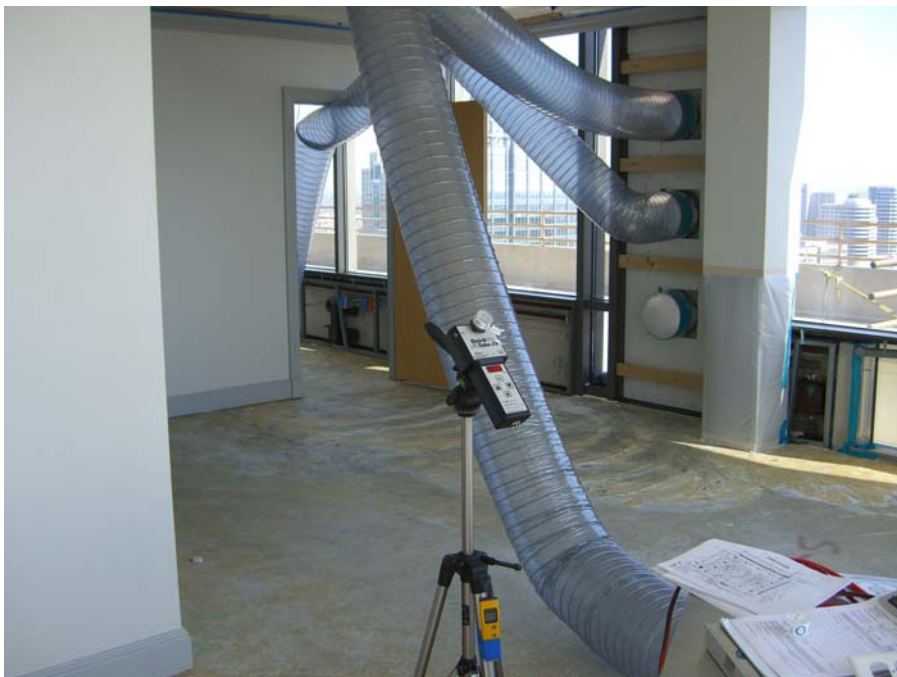
- 4) Additional image of air sampling and air handling equipment within 23 East containment area at time of assessment.

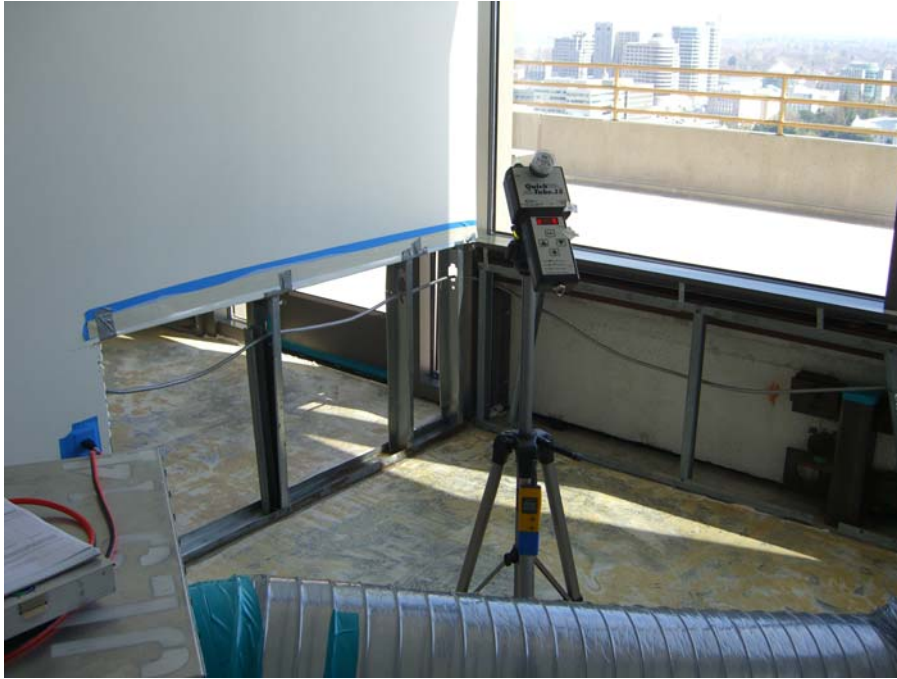
- 5) Image within 23rd Floor east containment area indicating location of air sampling equipment and extent of perimeter and interior wall removal.

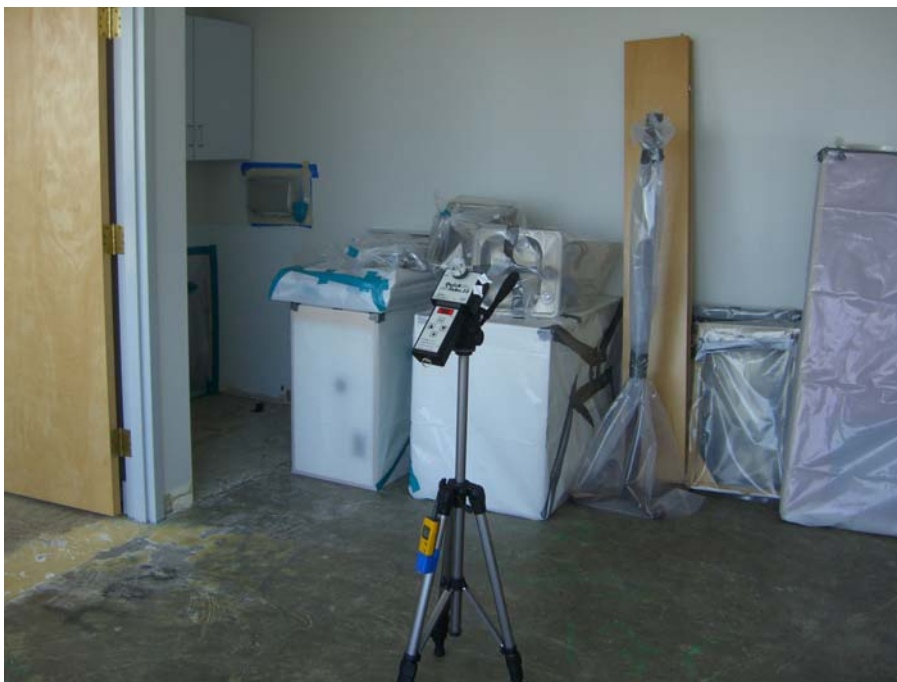
- 6) Image of protected office furnishings located within interior office where air sampling was performed as part of this assessment.

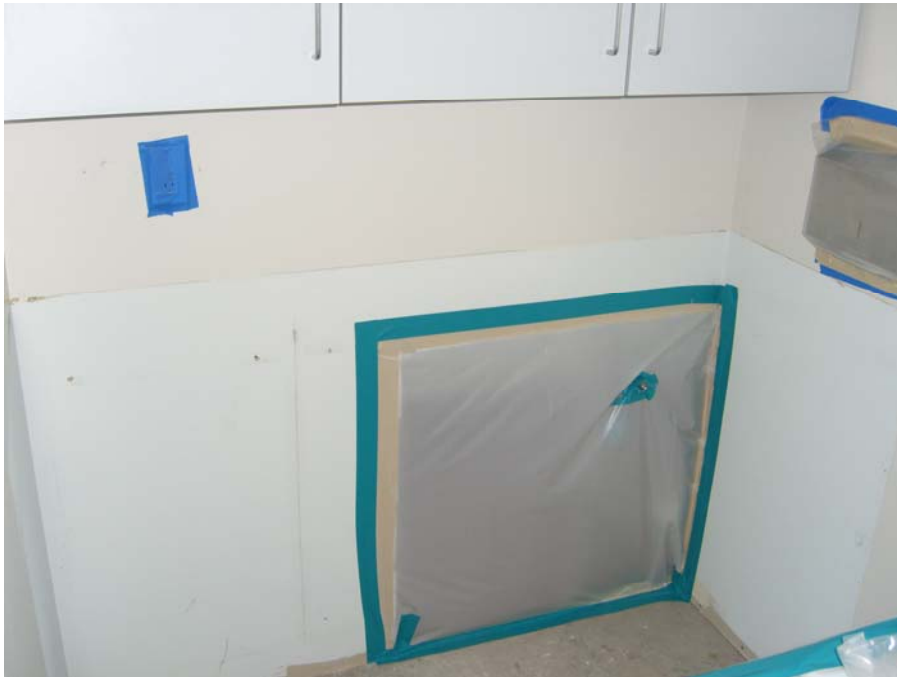
- 7) Close-up image of mini coffee bar cabinet location indicating wallboard and cabinet removal prior to clearance assessment within 23 East containment area.

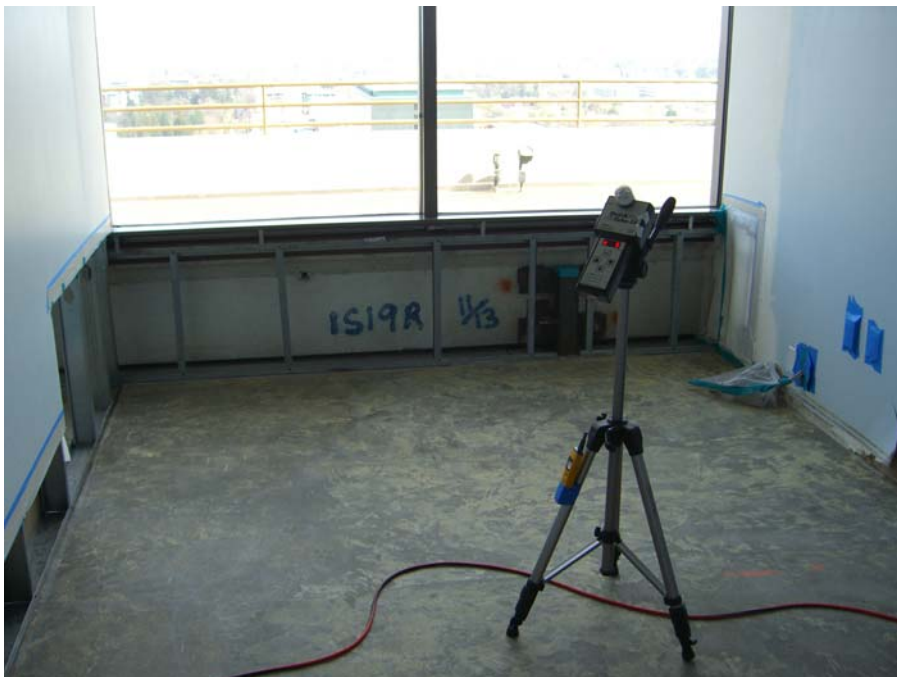
- 8) Air sampling within 23 East containment perimeter office space indicating extent of exterior and interior wallboard removal.

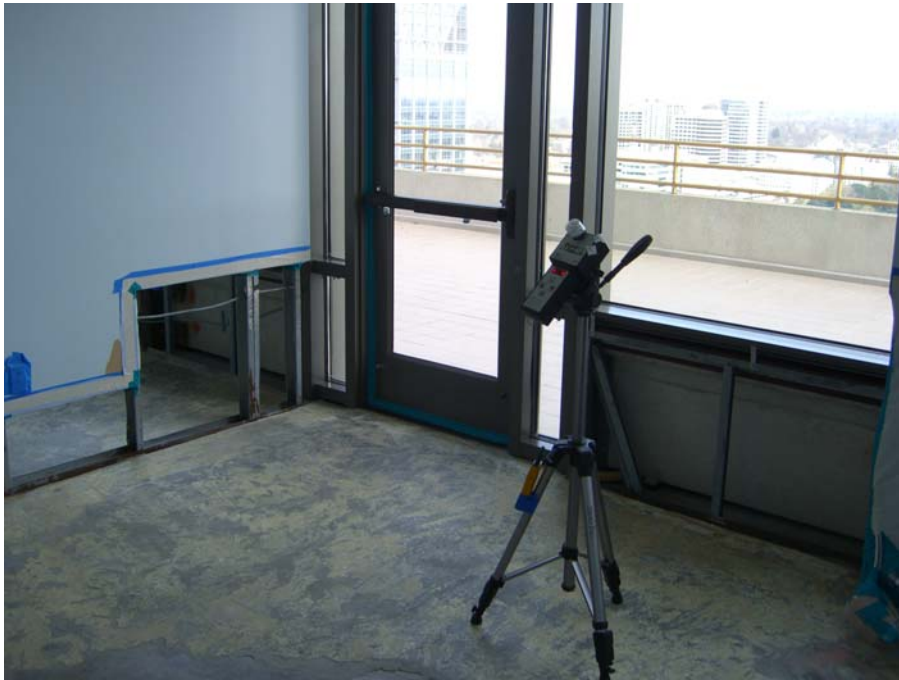
- 9) Additional image of air handling equipment location within 23 East perimeter office at doorway location.

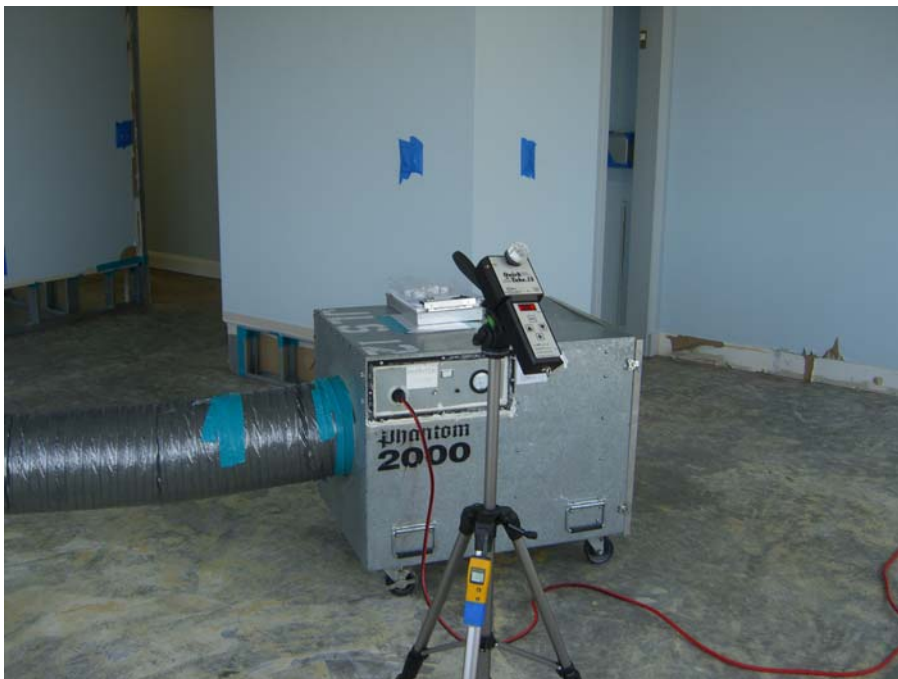
- 10) Image of air sampling equipment within 23 East containment area.
